Manhole Inspection Summary

Manhole # S65Q__008MH

Insp Date: **3/6/08 9:59 AM**

Location Address: **6101 Cardiff Ave.**

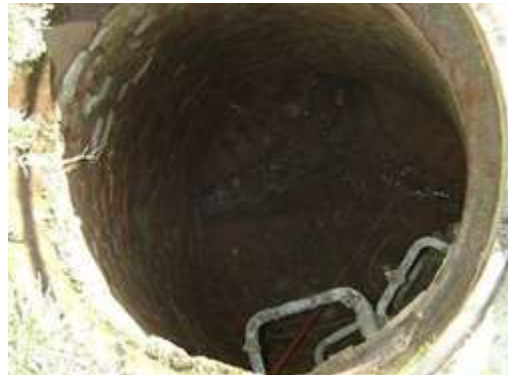
Top View

Comments **THERE IS HEAVY DEBRIS IN THIS MANHOLE THAT MAY CATCH OTHER DEBRIS CAUSING A PROBLEM.**

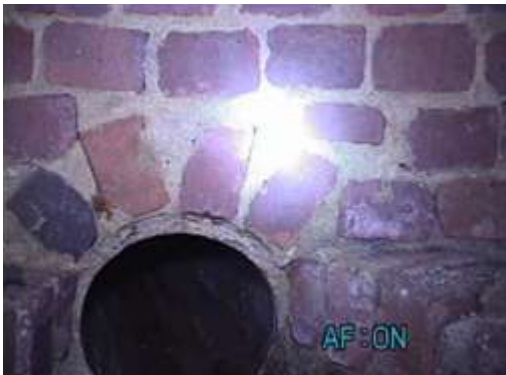
Defect 1

Cracked pipe seal outgoing 12 O'Clock

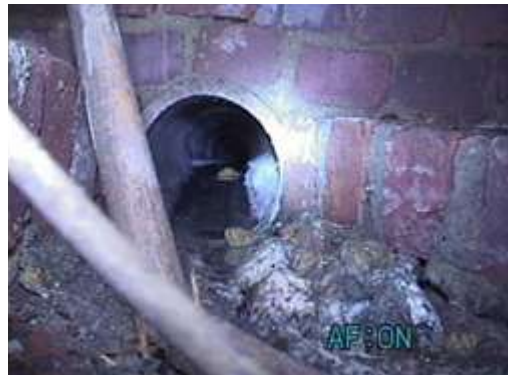
Defect 2

Condition: ☐ Sound ☐ Cracked ☐ Root Intrusion ☒ **Deteriorated** ☐ Leaks ☒ **Debris**

missing mortar in channel.

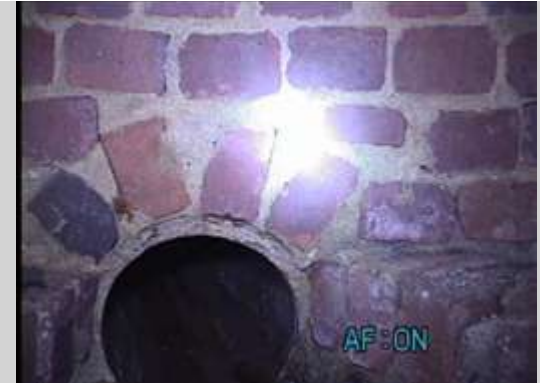
12 O'Clock Outflow

Pipe Height: **8.4** (in.) Rod and Bar (Angled)
Pipe Material: **Clay** ☐ Pipe Lined
Invert Depth: **8.58** (ft.) Flow Characteristics: **None**
Deposits: ☒ None ☐ Mud ☐ Sludge ☐ Debris ☐ Grease
Silt Depth: (in.) Deposits Extent:
Infiltration: **Evidence** Pipe Seal Cond: **Cracked**

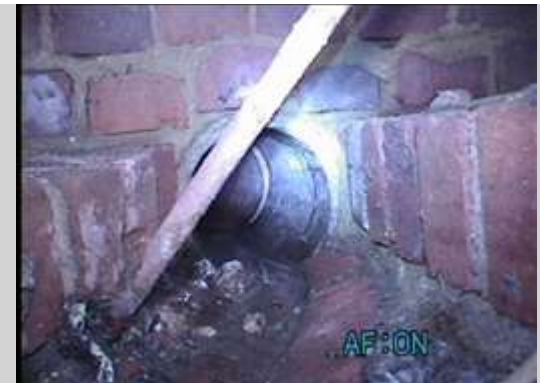
3 O'Clock Inflow

Pipe Height: **6** (in.) Rod and Bar (Angled)
Pipe Material: **Clay** ☐ Pipe Lined
Invert Depth: **8.29** (ft.) Flow Characteristics: **None**
Deposits: ☒ None ☐ Mud ☐ Sludge ☐ Debris ☐ Grease
Silt Depth: (in.) Deposits Extent:
Infiltration: **None** Pipe Seal Cond: **Sound**

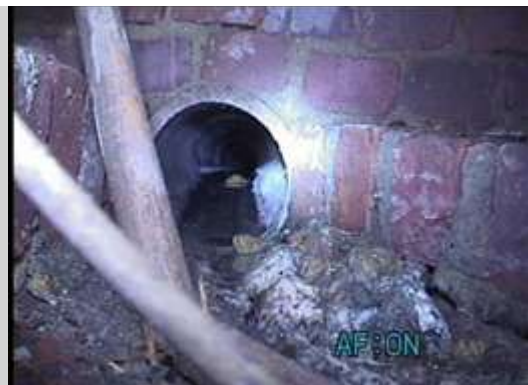
9 O'Clock Inflow

Pipe Seal Cond: **Sound**
